**Condensation Dryer NEXUS 4 series**

**599 521 868 EN**

**New float microswitch and float body.**

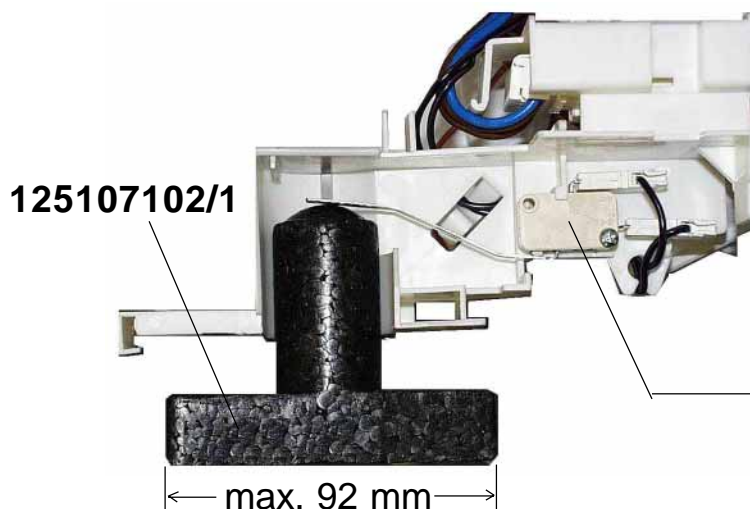
The display provides the information that the condensate receptacle is full; there is however no or too little condensate in the condensate receptacle.

One possible cause for the error was determined to be the „float type switch“, spare part No. **125 851 315/7** or **125851313/2** respectively, they having a gold contact layer which has not always been homogenously applied to the internal switch contact layer. This can result in partial contact uncertainties/interruptions.

The microswitch is an opener contact. When the condensate rises, the float floats upwards, activates the switch and the pump is activated. The falling water level reactivates the switch. Due to the aforementioned contact uncertainty, it is possible that the contact can be temporarily interrupted although a mechanical switch-over has internally taken place. Via the time-related inquiry routine, the „interrupted“ contact in the electronics system is interpreted as >receptacle full< and this is then displayed accordingly.

**old - 125851315/7**  
**old - 125851313/2**  
**new - 125851316/5**

**In case of doubt, the old microswitch must be replaced.**

**Besides the microswitch, you should also replace the float body or at least check the long dimension of the lift cuboid (< 92 mm).**

**Manual cutting off to 92 mm is also possible.**

The previous microswitches for the customer service have already been replaced by a new improved type with the spare parts No. 125 851 316/5 and the spare parts inventory has already been adjusted.
