Quick Startup Guide for SIMODRIVE 611 Universal

1.1 Overview

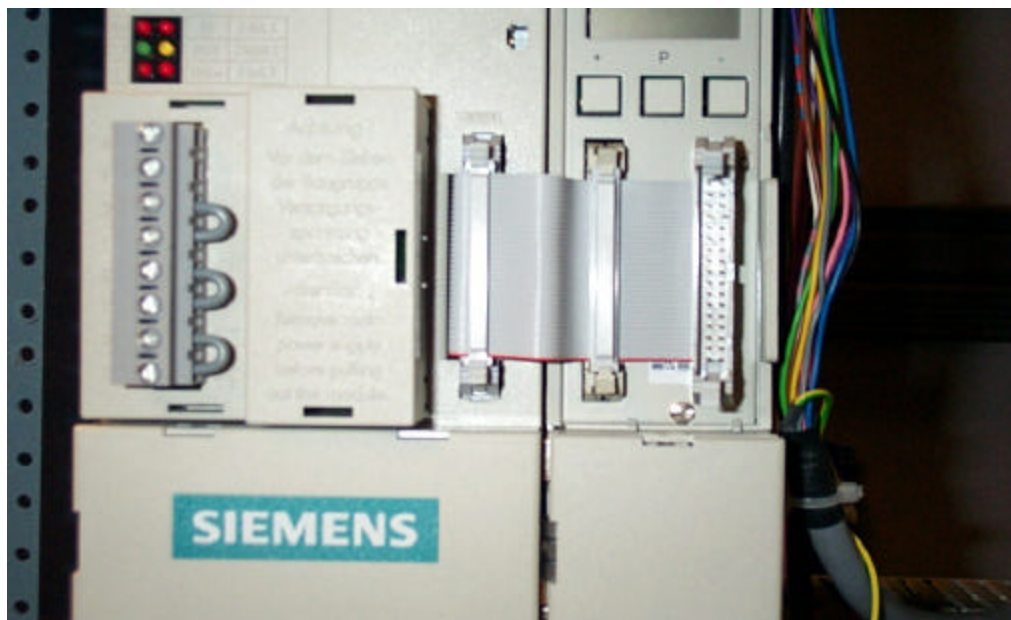
Picture 1-3 24V electronic power supply

- The 24V, 15V, & 5V DC electronic power supply is connected via the ribbon cable in front of the drive. The cable is provided with every Power Module.

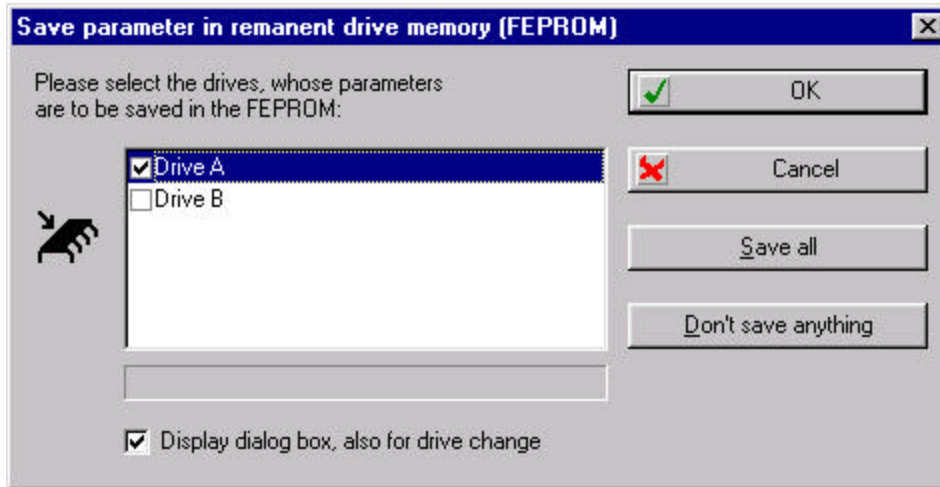
Fig 4.6.9

Parameter changes in Simocon U are not automatically saved in the 611U's memory. The drive settings must be saved in FEPROM if desired. Complete this path to save parameter changes in the drive, File → Save in drive → (Choose Drive A or Drive B → OK).

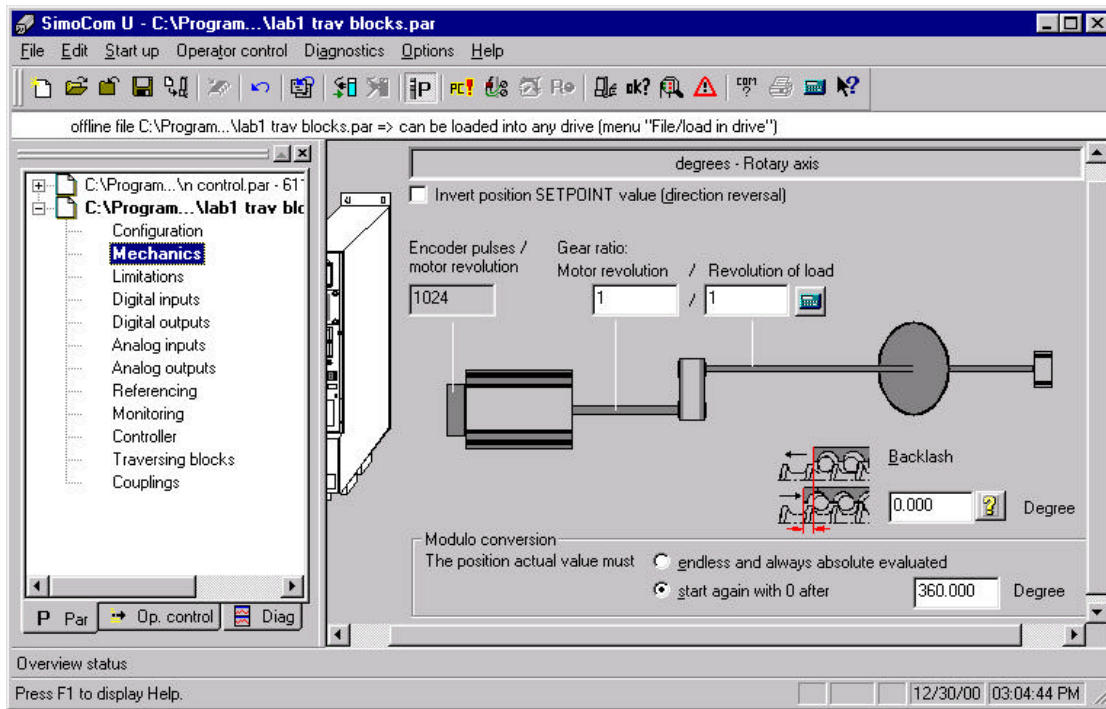
Fig 4..6.12

The next setting in Simocon U needed is the Mechanical Settings. This block will confirm that the Rotary Axis has been selected, Gear Box ratio, and Pulse Encoder PPR is correct. Select Modulo conversion as selected in Fig 4.6.12, with 360 Degrees selected and start again with 0 after 360 degrees selected. This is for experimenting only and specific applications will require different settings if applicable. See Fig. 8.2 for more information on Mechanical Settings.

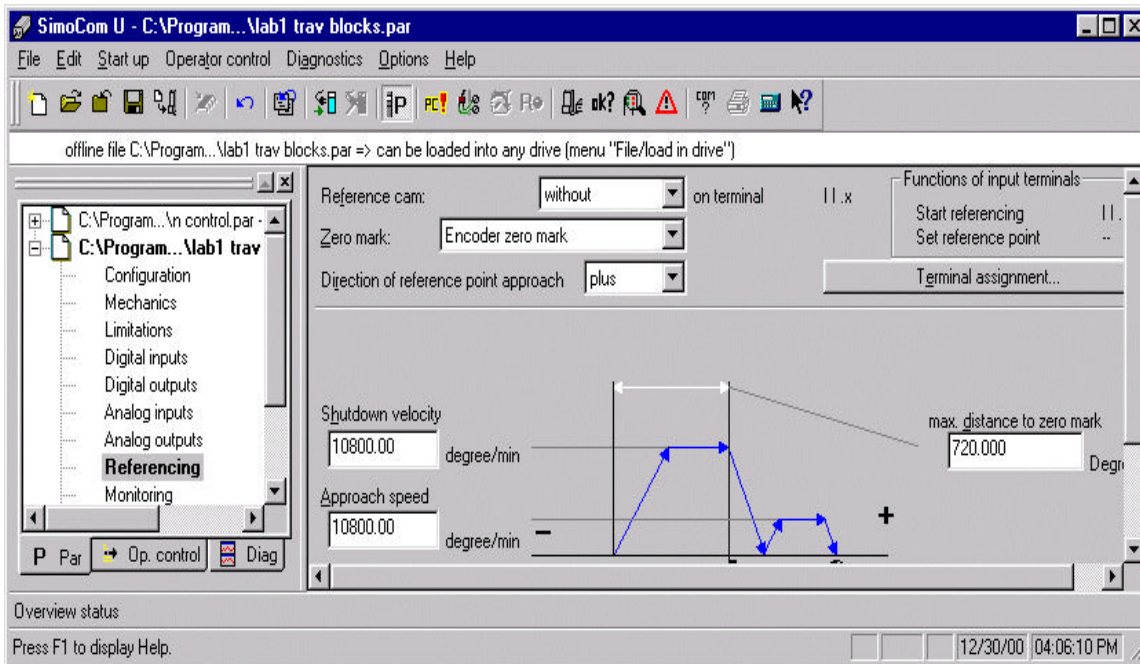
Fig 4.6.14

Set Reference Cam to “Without” and Zero Mark to “Encoder Zero Mark” as seen below.

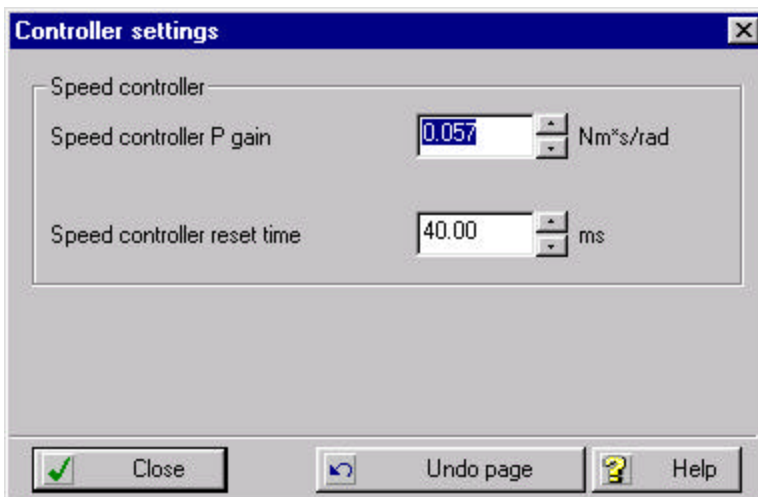
Fig. 4.6.15

Execute the Speed Controller as we have before in the previous section. Don't forget to save new settings to FEPR0M and note settings.

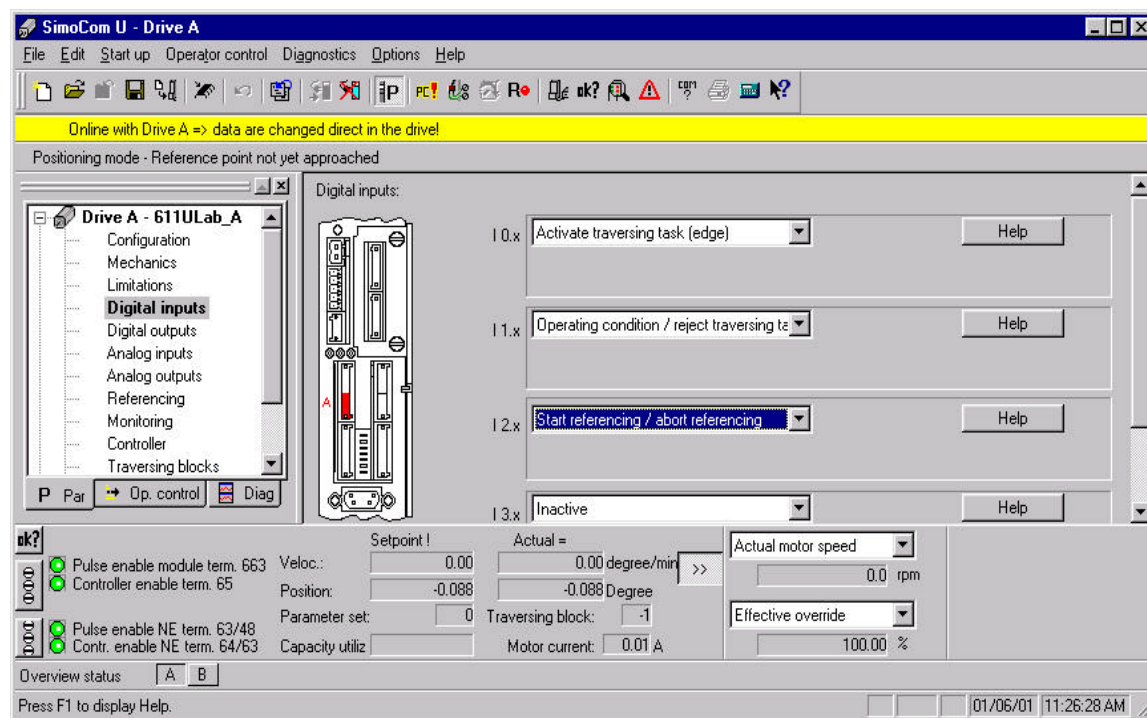
Fig. 4.6.17

- I0.X to “activate traversing task (edge)”
- I1.X to “operating condition / reject traversing task”
- I2.X to “Start referencing / abort referencing”
- I3.X to “Inactive”

See Figure 4.6.17 below for exact settings.

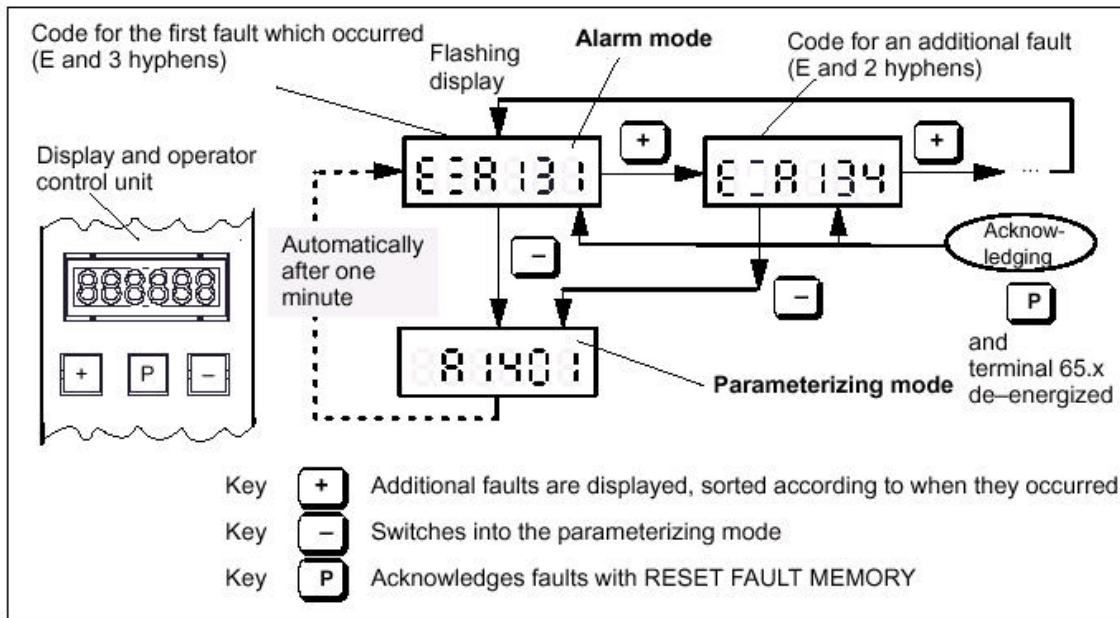
When faults occur, they can be handled using the PLUS, MINUS and P keys as illustrated in the following diagram.

Fig. 6-2 Handling several faults
